Letter to Editor

Misplacement of the tip of central venous catheter after cardiac surgery

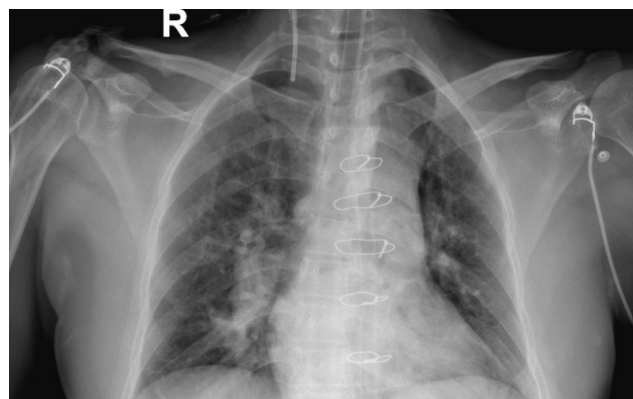
Fig. 1: Chest radiograph showing higher placement of the CVC (central venous catheter)

The surgical procedure was uneventful and the patient was shifted to the intensive care unit (ICU) for monitoring and mechanical ventilation. Chest radiograph in ICU revealed higher placement of the CVC and tapering tip

of the catheter was also not seen. (Figure 1) On zooming the image all three lumens of the catheter were visualized which look like transection of CVC. (Figure 2) The surgical team also denied accidental cutting the tip of catheter and revealed that the tip of catheter was not visualized intraoperatively. To look for the missed portion of CVC it was decided to repeat chest radiograph including the cervical region which showed looping of the CVC (U-shaped) within IJV. (Figure 3) Rest of the postoperative course was uneventful and CVC was used for infusions and was removed on second postoperative day with intact tip as per our protocol.

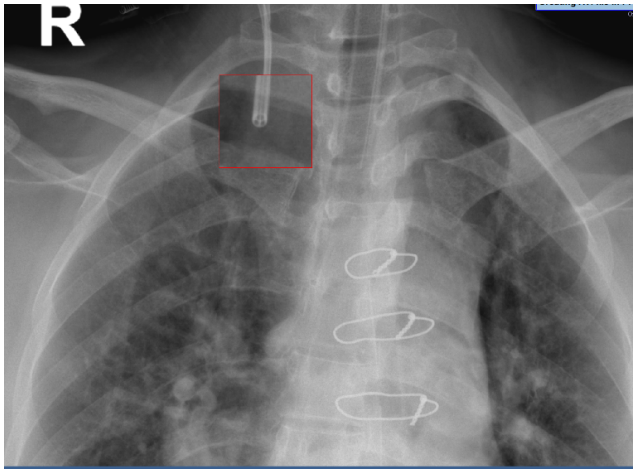
Fig. 2: Zoomed view showing all lumens of the CVC

manipulation during superior venacava cannulation may cause dislodgement of the tip of catheter which was again not in this case. In this patient the zoomed radiograph image revealed all lumens of the CVC that lead to doubt of transection of the catheter which is sometimes electively done by surgeons in case of extra length in the surgical field. However, that was also ruled out by the surgical team. Another theory is that venotomy and cannulation of SVC for CPB might lead to displacement of CVC which was again not there in this case.³

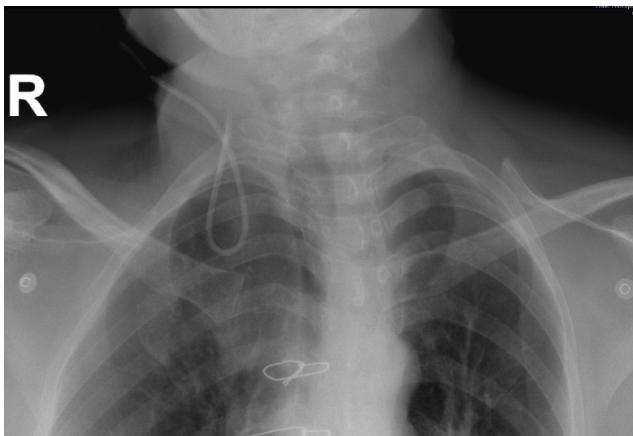
Fig. 3: Chest radiograph showing looping of the CVC

Intra-atrial ECG monitoring can be used for positioning of the guidewire.⁴ In view of above radiograph of abdomen was also done but that was inconclusive and repeat scanning of the chest showed looping of the catheter.
